DEPARTMENT OF TRANSPORTATION

Contract #: 04-0120F4Cty: SF/ALA Rte: 80 PM: 13.2/13.9File #: 1.28**WELDING INSPECTION REPORT****Resident Engineer:** Pursell, Gary**Address:** 333 Burma Road**City:** Oakland, CA 94607**Report No:** WIR-015758**Date Inspected:** 22-Jul-2010**Project Name:** SAS Superstructure**OSM Arrival Time:** 700**Prime Contractor:** American Bridge/Fluor Enterprises, a JV**OSM Departure Time:** 1530**Contractor:** American Bridge/Fluor Enterprises, a JV**Location:** Jobsite**CWI Name:** See below**CWI Present:** Yes No**Inspected CWI report:** Yes No N/A**Rod Oven in Use:** Yes No N/A**Electrode to specification:** Yes No N/A**Weld Procedures Followed:** Yes No N/A**Qualified Welders:** Yes No N/A**Verified Joint Fit-up:** Yes No N/A**Approved Drawings:** Yes No N/A**Approved WPS:** Yes No N/A**Delayed / Cancelled:** Yes No N/A**Bridge No:** 34-0006**Component:** SAS OBG**Summary of Items Observed:**

WELDING INSPECTION REPORT

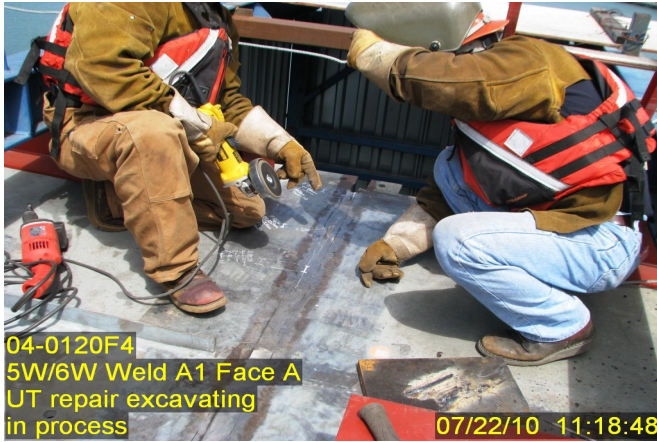
6). OBG Field Splice 5W/6W Weld ID: A1, Face A

The QAI periodically observed AB/F approved welder James Zhen (ID 6001) grinding to excavate Ultrasonic Testing (UT) rejected indications on the A face of the OBG Field Splice 5W/6W Weld ID: A1. The QAI noted that there are several indications marked on the weld A1. The (3) three indications (shown in the photo below) are in the 20mm thick Corner Assembly weld that was observed by the QAI on 7-9-10 to be welded per the FCAW-G process by AB/F approved welder Hua Quiang Hwang (ID 2930).
